Project Effectiveness Evaluation

Summary of Findings

February 1, 2024

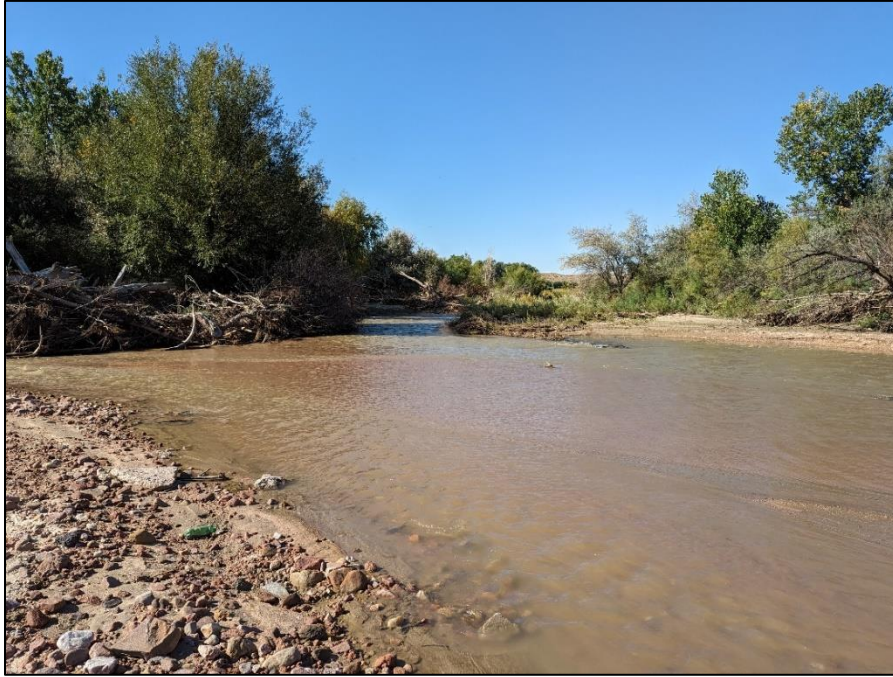
Figure 3. Mainstem of Fountain Creek through the Masciantonio project area.

Site assessment was completed and included the Masciantonio project area, completed in 2018, and the Young Hollow drainage project, completed in 2020. In the Masciantonio project area, dense vegetation and a multi-threaded channel was observed. The mainstem of Fountain Creek has established to the east of the eroding bank and is shown in Figure 3. Observations noted heavy riparian vegetation on the banks and on the islands. Large debris piles, 5 to 6 feet high, were located throughout the area, likely a result of recent floods.

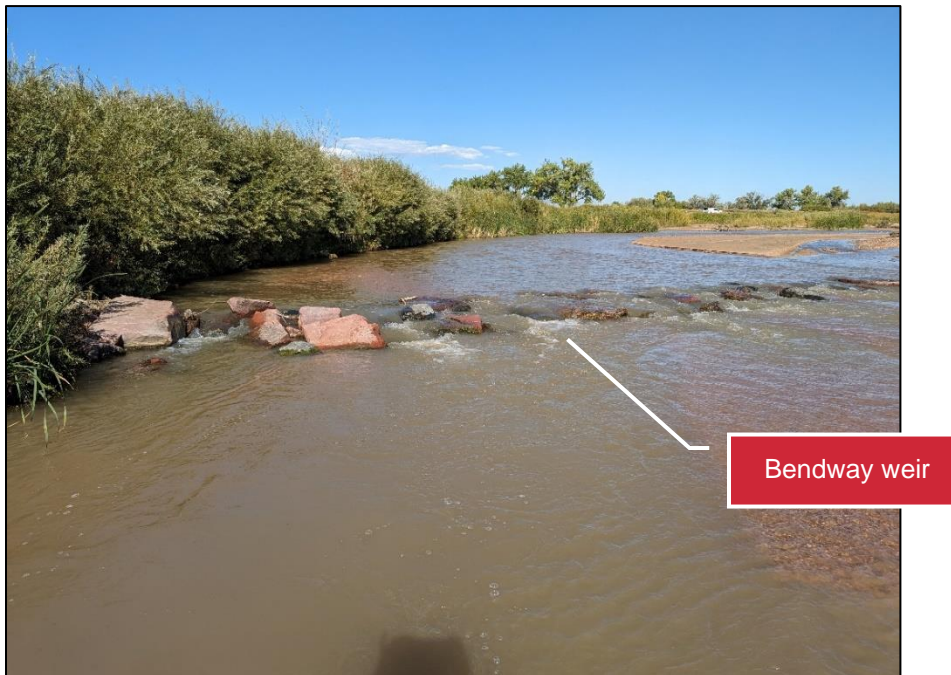
Figure 4. Buried bendway weir.

Along the historic mainstem where the bendway weirs were installed, significant sediment deposition has occurred, increasing the channel bed elevation to at least the top of the weirs. Only one of the structures could be seen on site, shown in Figure 4. This structure is providing minor grade control and trapping aggraded sediment behind it.

Based on the buried condition of the bendway weirs, it is likely that this area has been serving as a site for sediment deposition in past years, holding large amounts of sediment that would otherwise have flowed downstream.

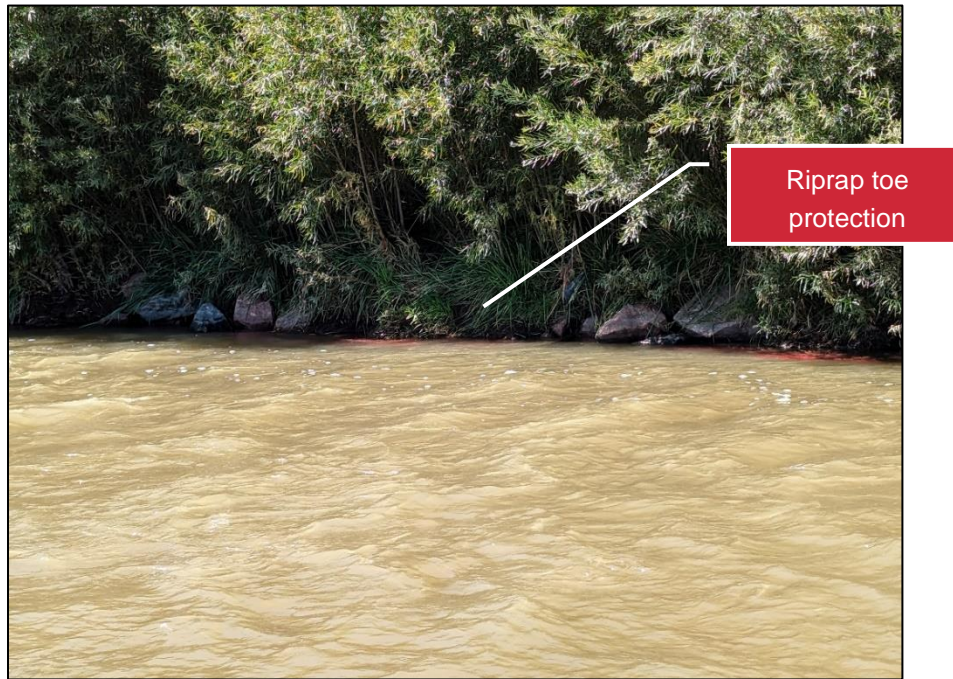
Figure 5. Longitudinal riprap toe.

The longitudinal toe protection installed at the two most downstream bendway weirs is visible and appears intact with large willows present throughout (Figure 5).

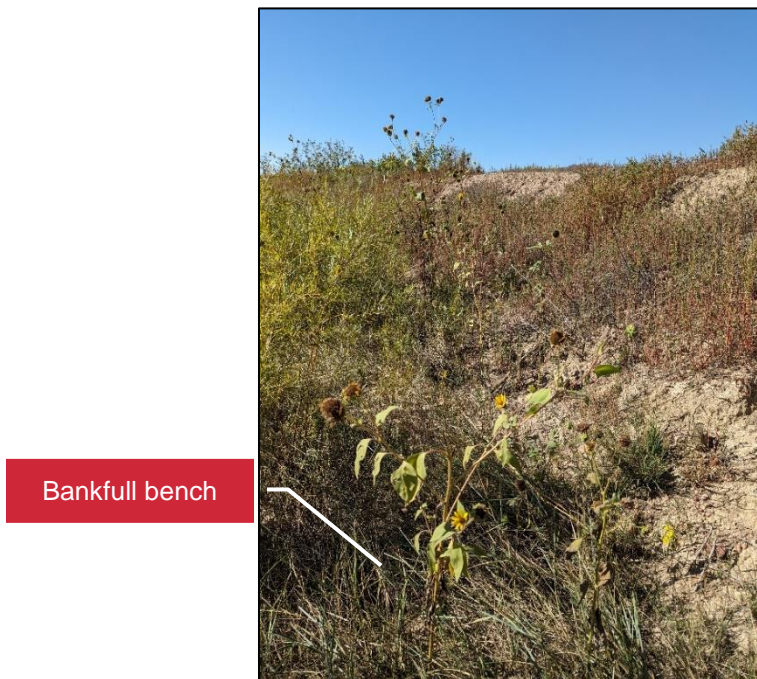
Figure 6. Bank PC003, Summer 2023.

The cut bank, Bank PC003, is sparsely vegetated along the slope with heavy vegetation on the bankfull bench protecting it from high velocity flow. Field observations noted evidence of flood flows extending across the bankfull bench and nearly to the toe of this slope.

Sediment contributions for the major cut bank stabilized as part of this project, Bank PC003, were estimated to be 13,653 tons/year in the WARSSS report (WARSSS, 2017). Based on the 2023 site assessment, the remnant bank is not exposed to flows and, therefore, is not providing any significant sediment contribution to the Fountain Creek system. Site observations did not note any newly eroding

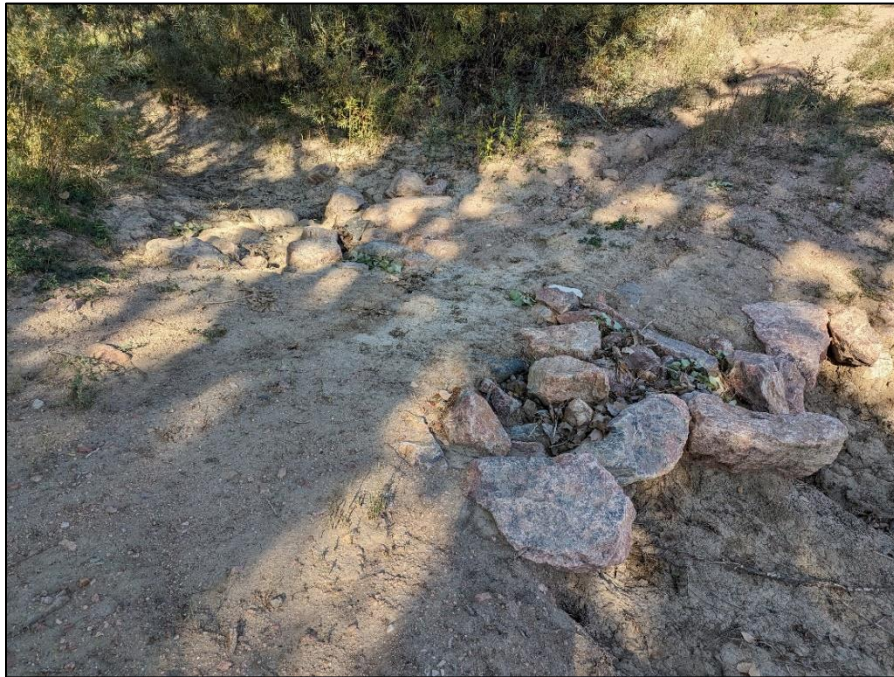
Figure 7. Young Hollow crossing.

Stabilization at Young Hollow consisted of work to convert a culvert throttling flow at a low water crossing along a farm road to a more open channel form. Riprap was buried in the low water crossing to provide

resiliency in large flow events. Figure 7 shows the crossing in Summer 2023. Some rock is exposed and there is evidence of large flows in the area.

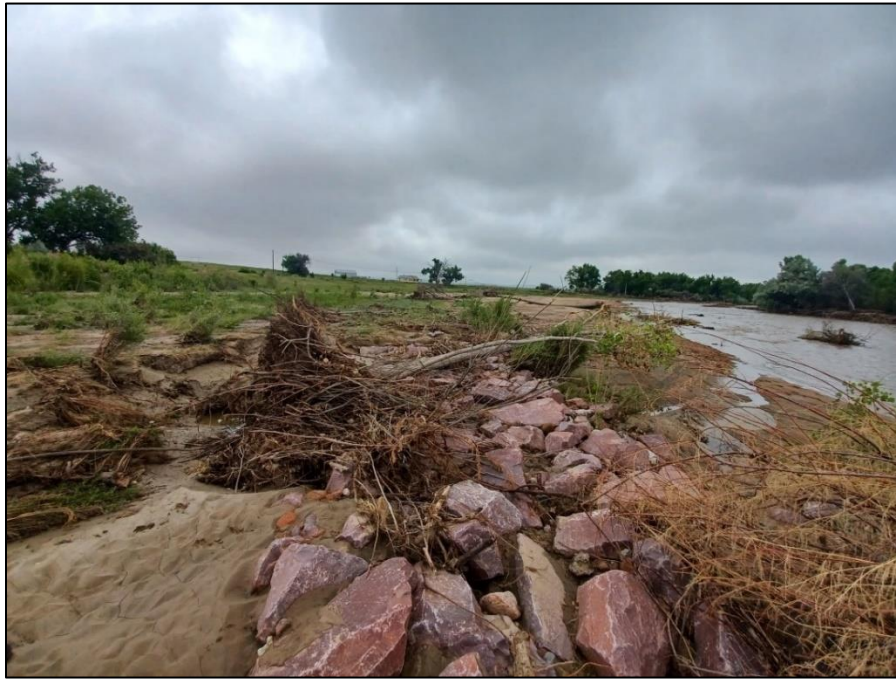
Figure 11. Riprap bank protection buried by sediment.

Significant sediment deposition on the outside of the downstream bend has occurred, burying the riprap bank protection and vegetation. In this condition Matrix was unable to assess the condition of the riprap. Figure 11 shows the bank protection, looking downstream, that was visible during the site visit, extending south into the sediment deposit.

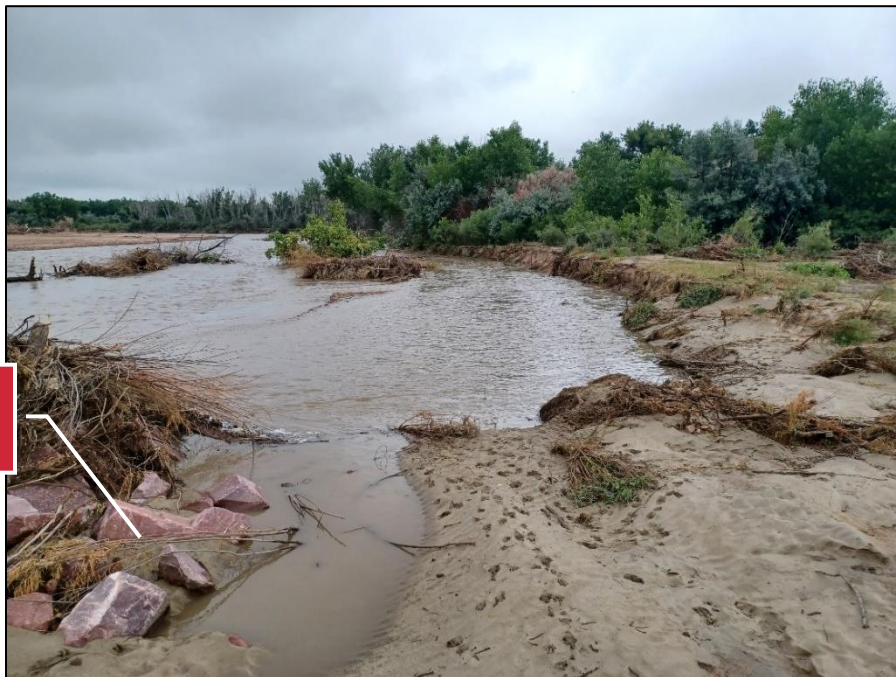
Figure 12. Upstream tie-in of riprap bank protection

The upstream side of this bank protection has been damaged by a buildup of debris, causing water to flank the protection. This is an area of concern that should be monitored. Note that flows on the date this photo was taken are greater than baseflow and therefore, water levels are higher than normal in this area.

Ongoing monitoring is recommended for the Overton Road site. At this time, the project is functioning, but the potential flanking noted at the lower bend protection is the area of highest risk for the project site. Sediment contributions from areas of the project site are noted but these are likely lower than pre-project conditions.

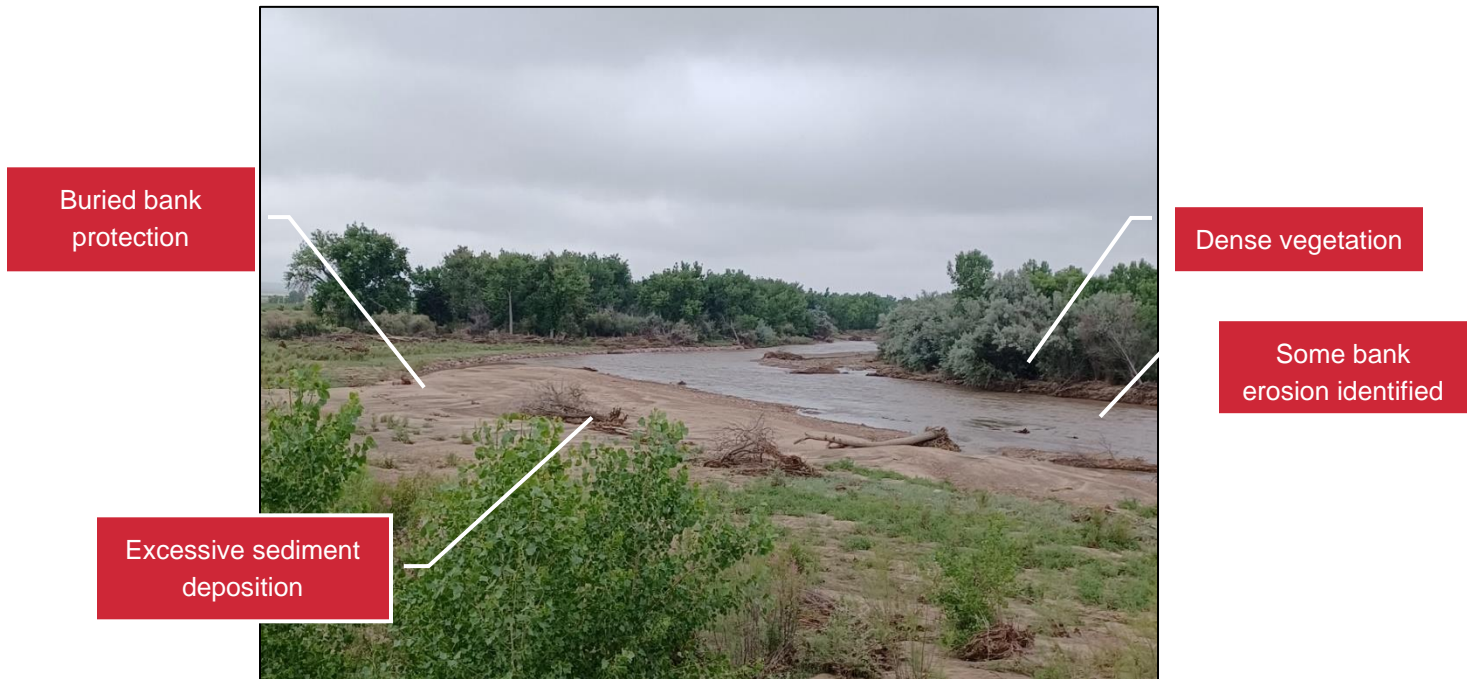
Figure 13. Overview of the downstream bend

The inside of this lower bend showed some bank erosion. This area is best shown in Figure 13, which includes additional annotation. This erosion could not be evaluated more closely due to high water

conditions on the day of the site visit. At this time, this is not an area of concern due to the heavy vegetation still present along the bank and no evidence that forces in the thalweg of the channel are pointed at the bank under normal flow conditions.

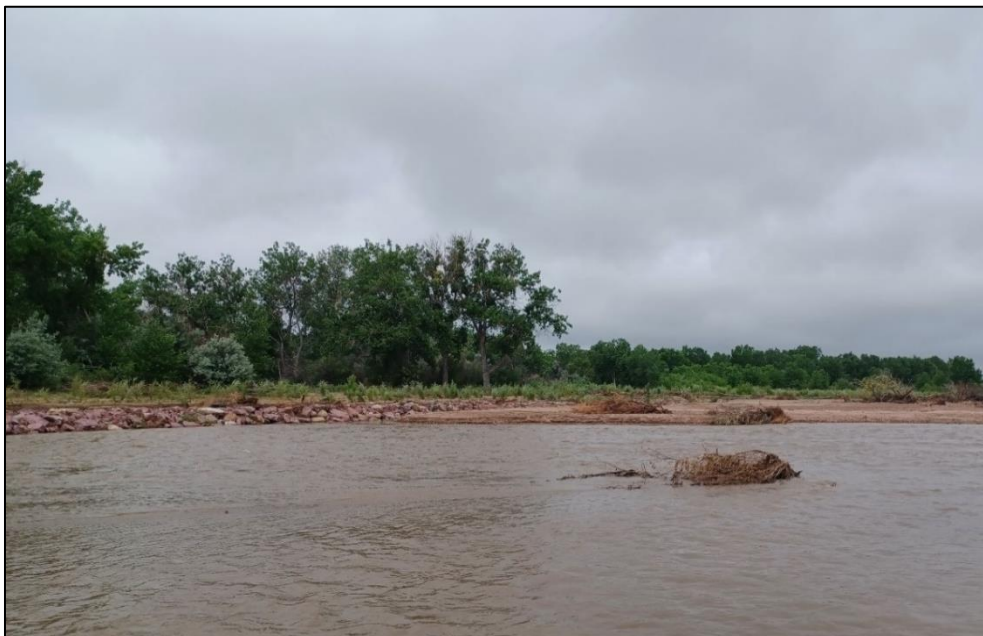
Figure 14. West bank of project area

The final area of analysis is the upstream bend. Bend protection is located on the west side of Fountain Creek which could not be accessed at the time of the site visit. This area is shown in Figure 14. The riprap bank protection appeared to be in good condition.

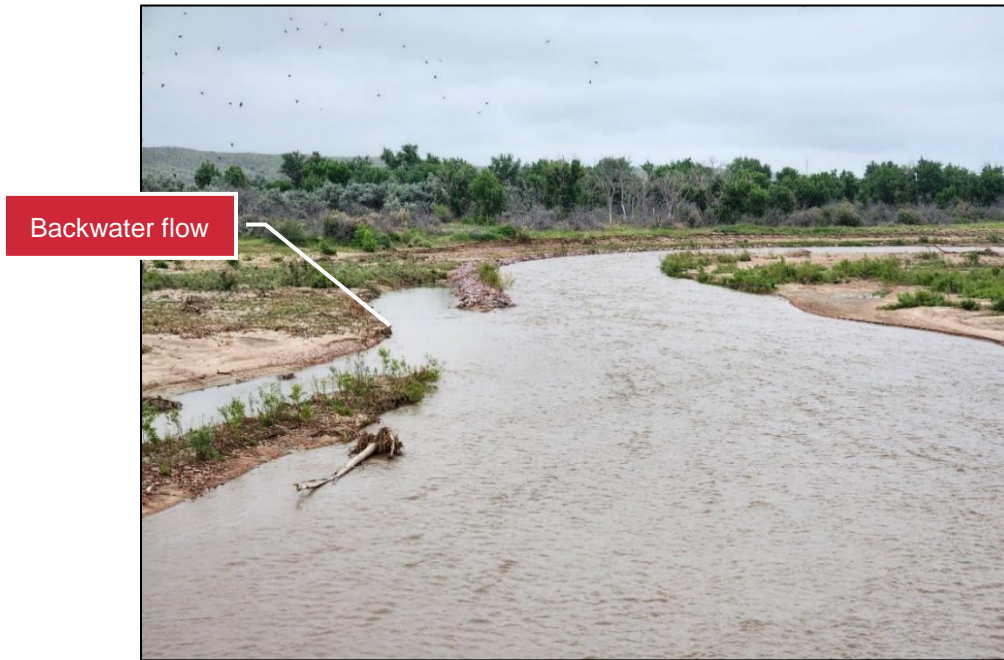
Figure 15. Riprap bank protection upstream of the Pinon Rd bridge, August 2023.

The Pinon Bridge site could not be accessed due to ongoing high water in the Summer of 2023. Visual assessment from the Pinon Rd bridge was conducted. Figure 15 shows the riprap bank protection upstream of the Pinon Rd bridge. This protection has been damaged by flooding on the downstream end and a backwater area has been scoured behind the riprap as noted in the image. Please note that this photo was taken at above average water levels that are greater than baseflow.

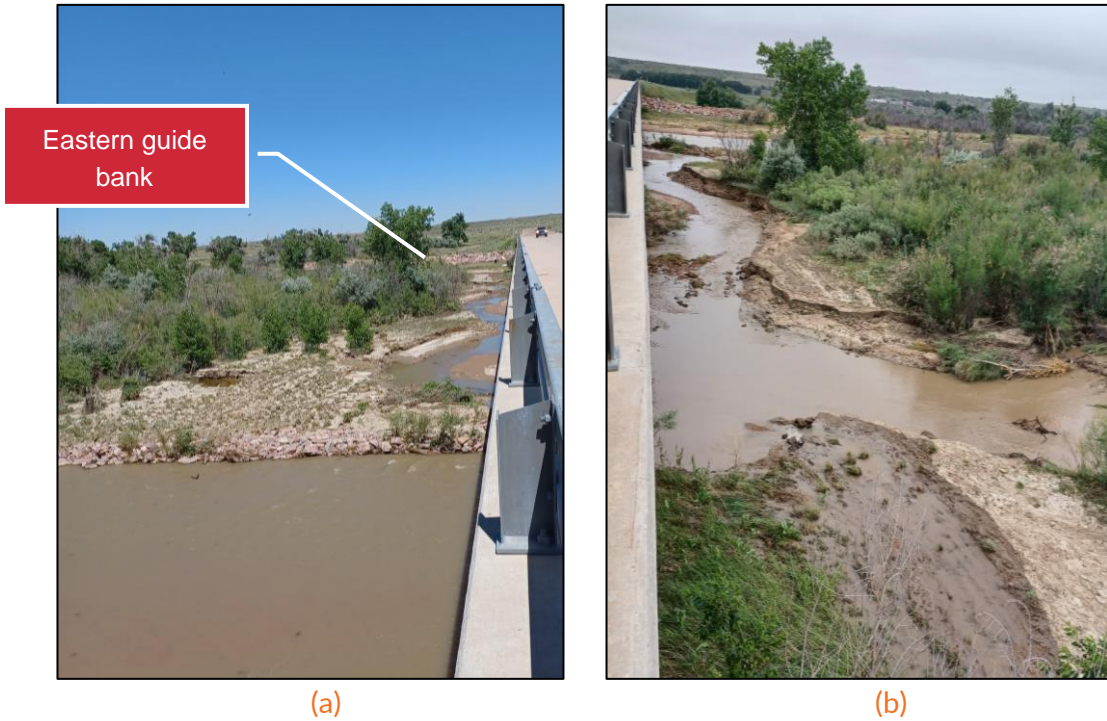
Figure 17. Floodplain impacts (a) Looking east. (b) Looking west.

Significant erosion on the eastern bank, outside of the project area, was noted and is shown in Figure 17. Based on site reconnaissance and aerial images, it appears a pond, located to the northeast of the project area, may be causing this new side channel to be cut into the floodplain. Though there is significant erosion on the floodplain, site observations showed the riprap bend protection remained intact. In a follow-up visit, this area appeared dry, reducing site concerns.

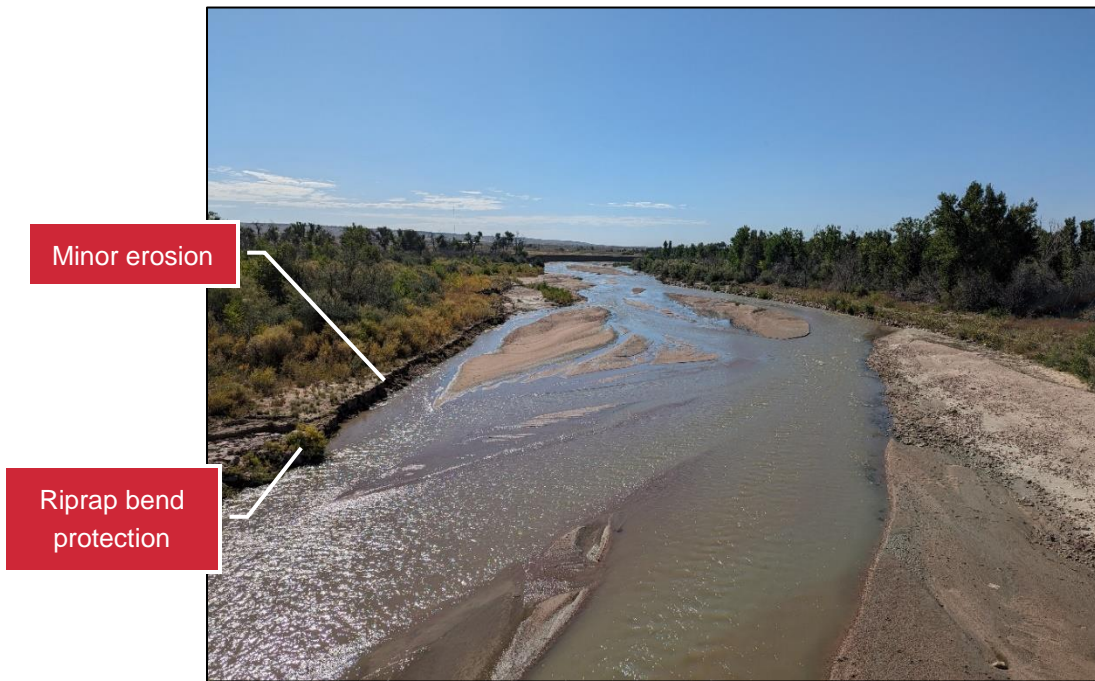
Figure 18. Project area downstream of the Pinon Rd bridge, September 2023.

Downstream of the bridge, the project area shows evidence of minor erosion downstream of the bend protection (Figure 18). Based on the flow path, this was likely caused by the flooding on the eastern bank of the channel. At this time, the erosion does not appear to be threatening the upstream bend protection or project as a whole. During the September visit, it appears a point bar is reforming in the bend of the channel.

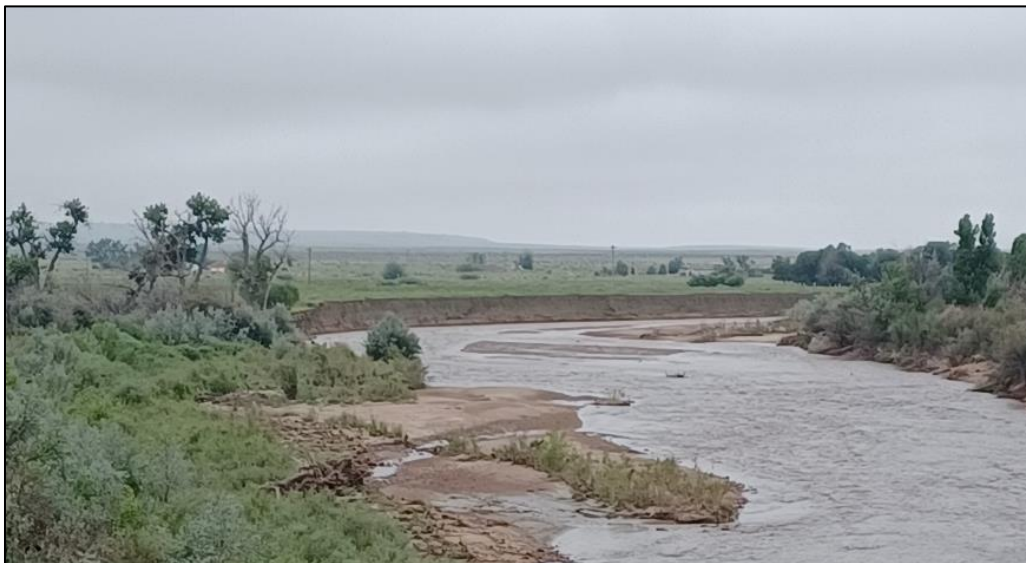
Figure 19. Eroding bank downstream of the project area.

Downstream of the project area, the bank shown in Figure 19 is actively eroding, retreating multiple feet during the recent flood events, according to the landowner. This bank was identified in the WARSSS report as Bank PC077 (WARSSS, 2017). If the retreat of this bank continues, it may put the Pinon Bridge project at risk.

This project site should be monitored for changes to site conditions that may put the site at risk. The backwater area near the upstream bend protection appears to be backfilling with sediment, so no action is recommended. Grading on Bank PC017 has stabilized the area from further erosion.

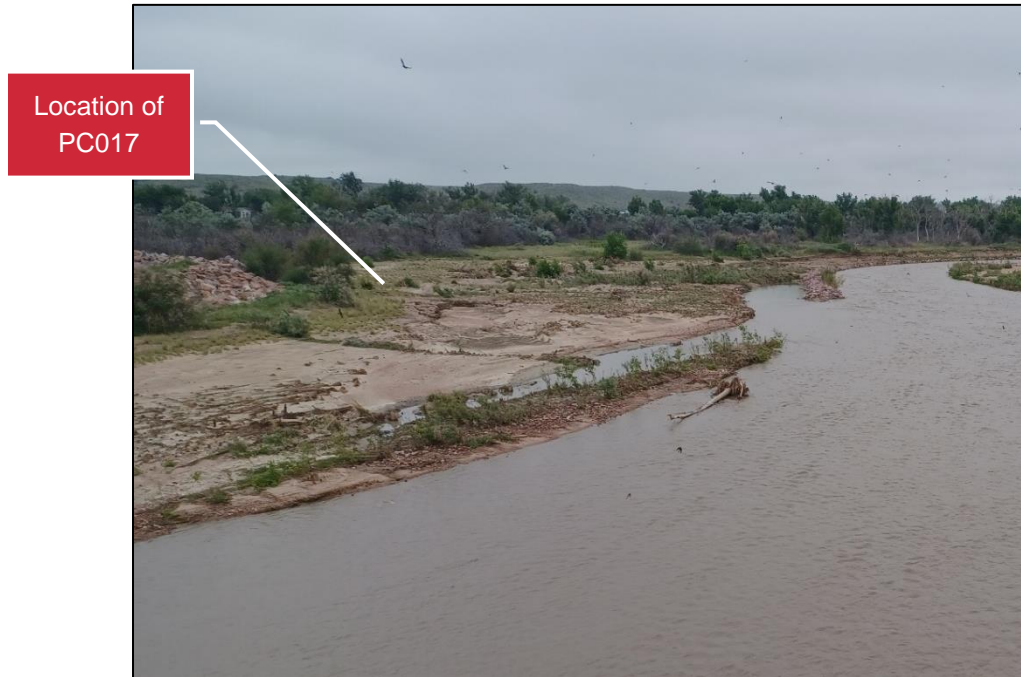
Figure 20. Area of Bank PC017.

The WARSSS report identified Bank PC017 as a high priority bank, contributing 9,242 tons/year to the system (WARSSS, 2017). The detailed BANCS assessment completed for the project area refined this estimate to 6,887 tons/year. Bank PC017 is called out in Figure 20. This bank has been stabilized and vegetated by the project and is no longer contributing sediment to the system.

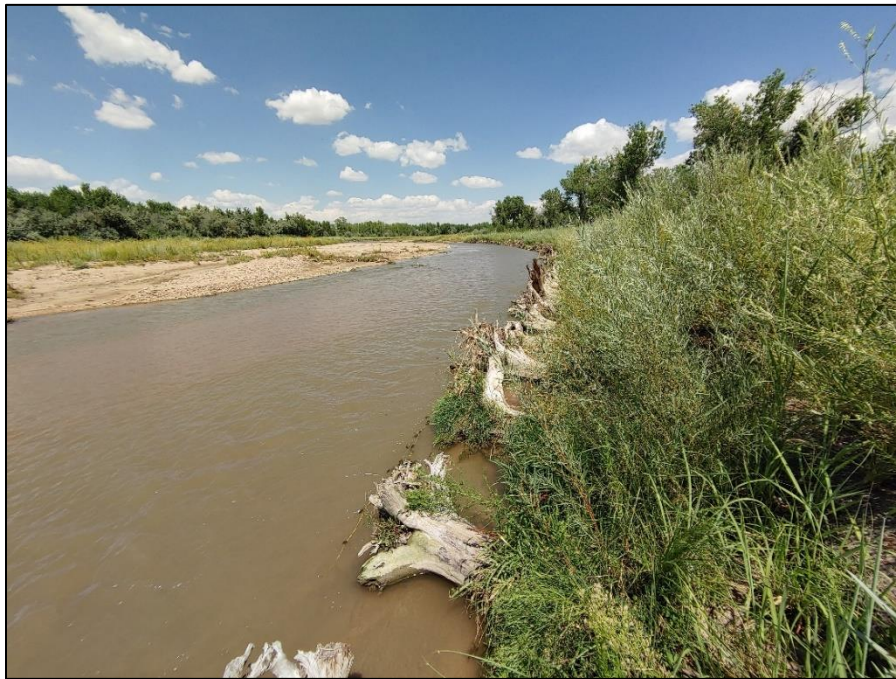
Figure 21. Bank Protection at Barr II, August 2021

Site visits in 2021, after project completion, showed good bank stability provided by the toe wood, soil lifts and vegetative success in willow plantings, especially towards the middle and end of the project area. Figure 21 shows the bank protection at a low flow condition.

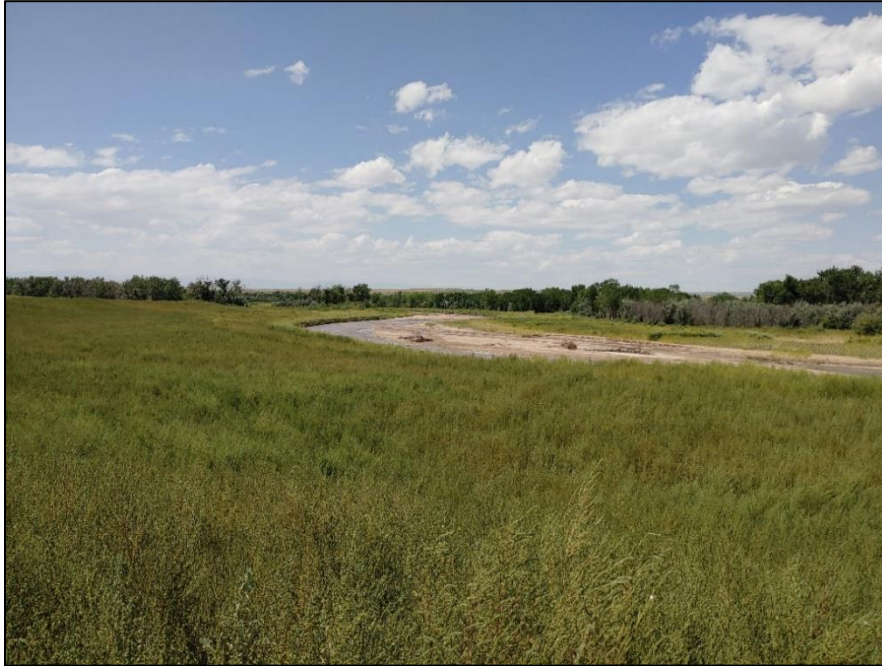
Figure 22. Bank PC078, post-construction, August 2021

Figure 22 shows how Bank PC078 was graded to a stable slope and the mainstem of Fountain Creek was moved to protect the agricultural fields to the east.

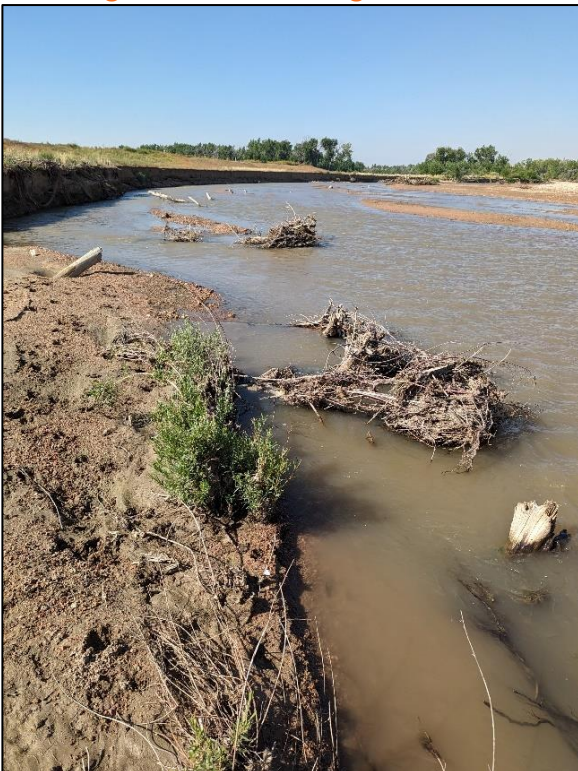
Figure 23. Damaged Toe Wood

The floods in 2023 were the first test for the project site. Major damage to the bank protection was experienced and is shown in Figure 23 and Figure 24.

Discussions of the mechanism of failure have been conducted and two potential causes have been identified. The first theory is that the soil lifts above the toe wood may have been undermined as rising water used the reduced permeability of the geotextile fabric placed between the logs and soil lifts to infiltrate the structure and exert a buoyant force on the soil lifts, resulting in their removal by flooding flows. The second theory is that rising water and turbulence around the root wads, and debris caught on the root wads, damaged the front face on the soil lifts and progressively caused the removal of the overburden soil above and behind the toe wood structure. Regardless of the actual mechanism, this loss of the soil lifts exposed the underlying toe wood structure to damage from high velocity flows and debris. Some areas of the site lost the soil lifts but retained the toe wood structure, as shown in Figure 24. These logs are exposed to additional damage and are at risk of future failure.

A combination of mechanical and chemical noxious and non-native weed control is recommended for the next two years to limit undesirable competition with establishing native vegetation. The project area should be monitored over the next two growing seasons to determine if additional adaptive management such as reseeding or replanting is necessary to provide additional soil stability. The project area should also be monitored for additional bank erosion which may result in threats to the adjacent agricultural assets.

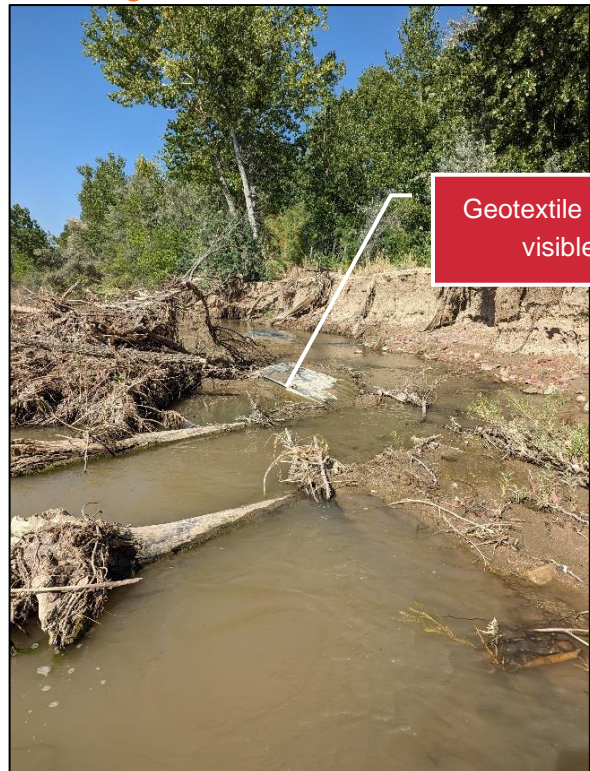
Figure 24. Soil Lifts removed.

Geotextile fabric visible

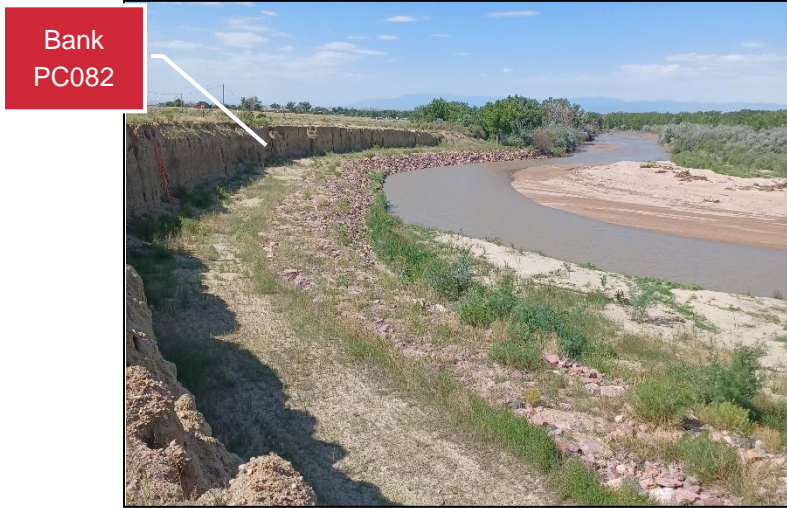
Figure 26. Lower tie-in bend with remnant cut bank.

The site was assessed downstream to upstream. The downstream tie-in of the project site was well established in the design pattern and a stable bar on the inside of the bend has been established. This area is shown in Figure 26. The top of the historic cut bank is still visible at the downstream tie in. Heavy wetland vegetation was found in this area due to good groundwater connection in the area, shown in Figure 27. At the upstream tie in of this bank protection, the soil lifts installed above the riprap are still intact with some loose fabric visible in Figure 28.

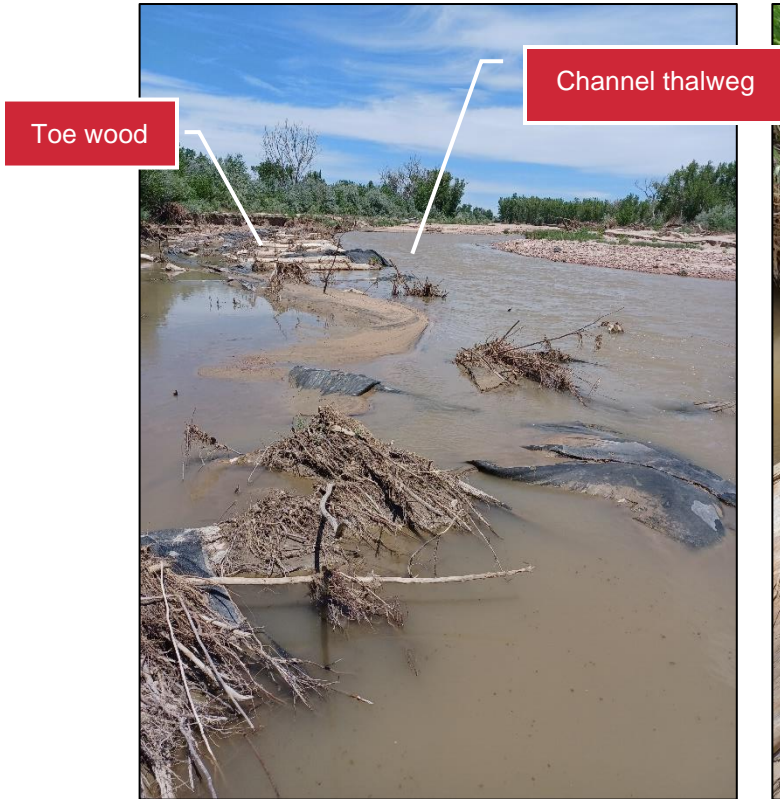
Figure 29. Remaining toewood structure.

The next bend upstream was the trial area for toe wood with soil lift bank protection that would later be built on Phase 2 of this project. In this area, most of the installed toe wood structure has remained intact but the soil lifts installed above have been compromised. This is shown in Figure 29 along with discarded geotextile fabric still present in the area of the structure.

During the site visit, it was noted that fine sediment was depositing behind and between the toe wood, backfilling the area. It appears that this bank protection was not exposed to the quantity of debris and stresses that impacted the upstream toe wood structures. Observations noted that the toe wood was directing flows away from the bank and maintaining the designed channel thalweg. On the downstream end of the toe wood, a large debris pile has protected the soil lifts. An example of this area is shown in Figure 30. Some of the material has been removed from the soil lift, but the fabric is intact and vegetation remains.

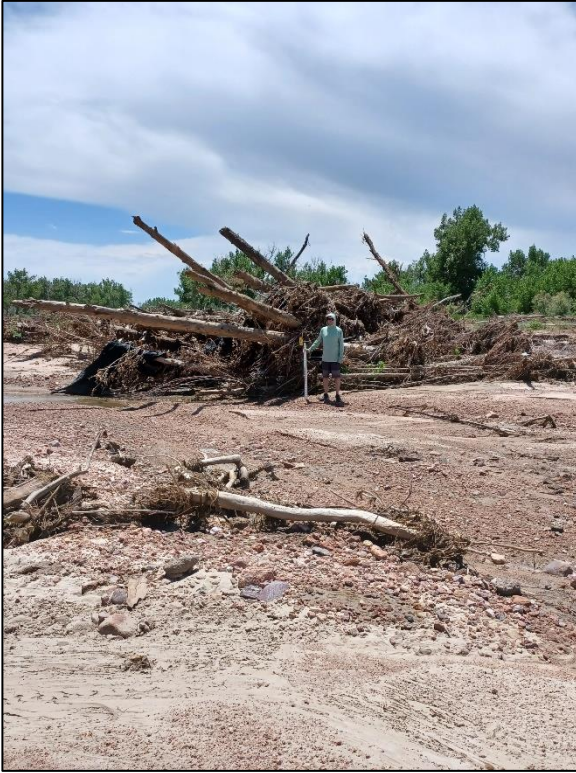
Figure 31. Large debris pile.

The next bend upstream returns to a riprap bend protection approach. A large debris pile is located at the upstream end of the bend and sediment has aggraded along the point bar, creating a narrow and confined channel along the bank protection as shown in Figure 31 and Figure 32. There was no evidence of the riprap becoming undermined due to this confinement and it appeared that flows were able to overtop the riprap bend protection and flood into the adjacent cottonwood gallery.

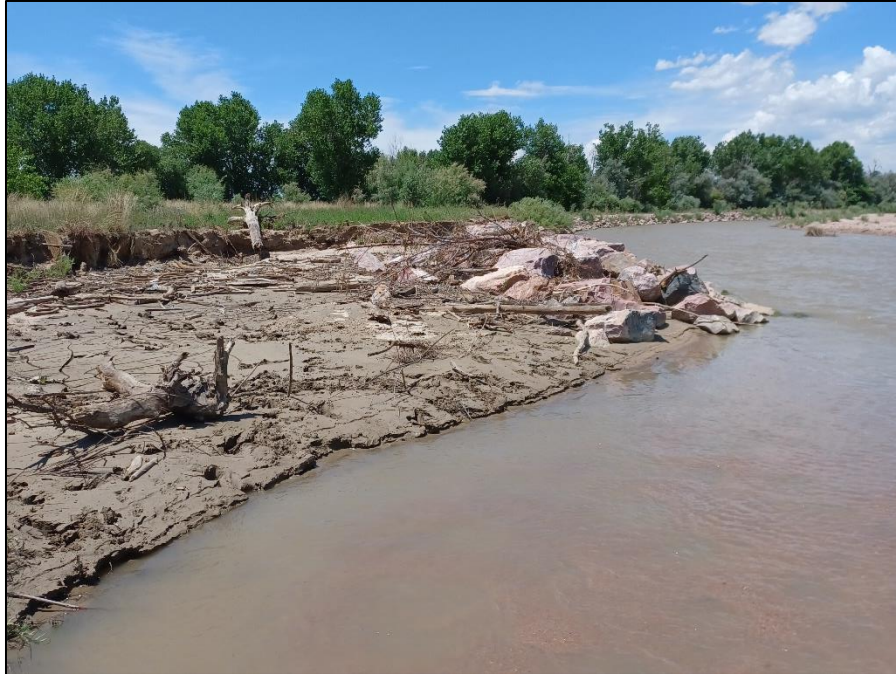
Figure 33. Upstream bend protection.

The final, most upstream bend of the project is protected by riprap bank protection. No significant damage was noted to this area. The downstream end of the protection shows evidence of scour behind the riprap, shown in Figure 33. This is similar to what was noted at the Pinon Road project and sediment has begun to backfill the area as well.
