APPENDIX C

Additional Information: Flooding and Stormwater Management

Fountain Creek Flood Summary

Trends in Precipitation and Streamflow in the Fountain Creek Watershed, Southeastern Colorado, 1977–99

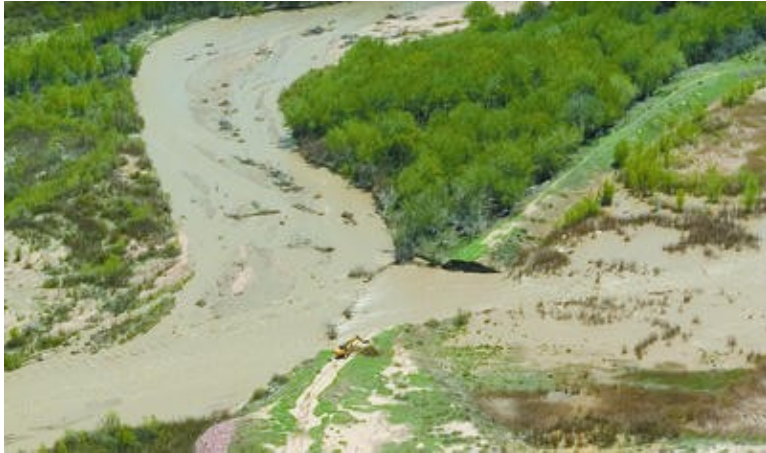
Attachment 2c - 2007

Water from the Fountain Creek spills into low-lying areas near Highway 47 and Dillion Drive where an embankment gave way Monday, flooding homes and businesses. Photo by Mike Sweeney 5.7.07

May 7, 2007 – In Pueblo, a newer roadway to a Wal-Mart Supercenter commercial district and a nearby, small residential neighborhood were swamped with water when an aged Fountain Creek levee broke after rainstorm runoff from the Colorado Springs area caused a shift in the creek's path through the area.

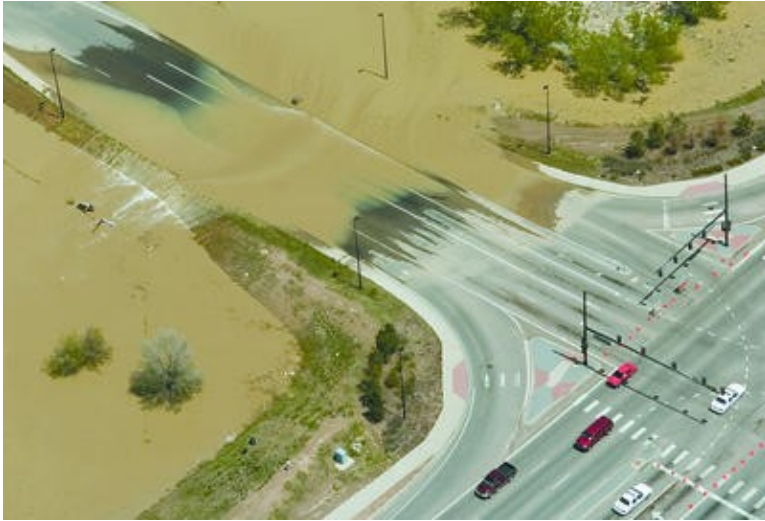
Attachment 2d - 2007

Flood waters spill over Dillion Drive Monday after a levee along the Fountain Creek broke, flooding nearby homes and businesses. Photo by Mike Sweeney 5.7.07

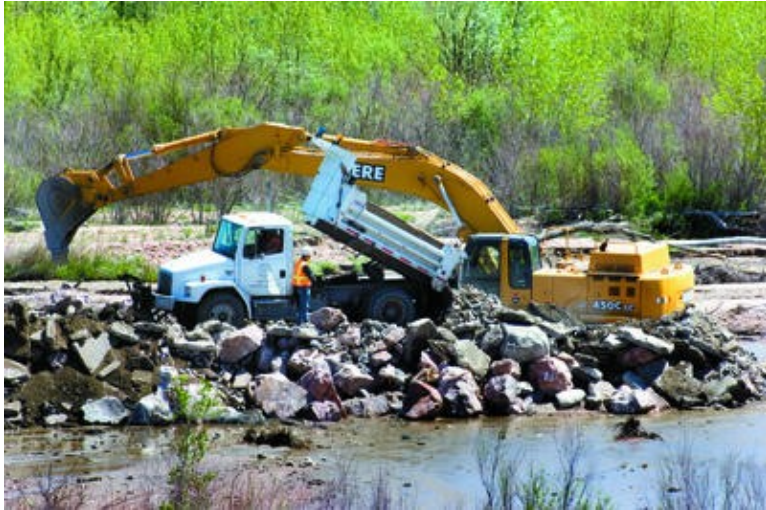
Attachment 2e - 2007

Crews work on replacing an old river levee which broke on the Fountain Creek Monday morning causing major flooding on Pueblo's northside. Chieftain photo John Jaques 5.8 07

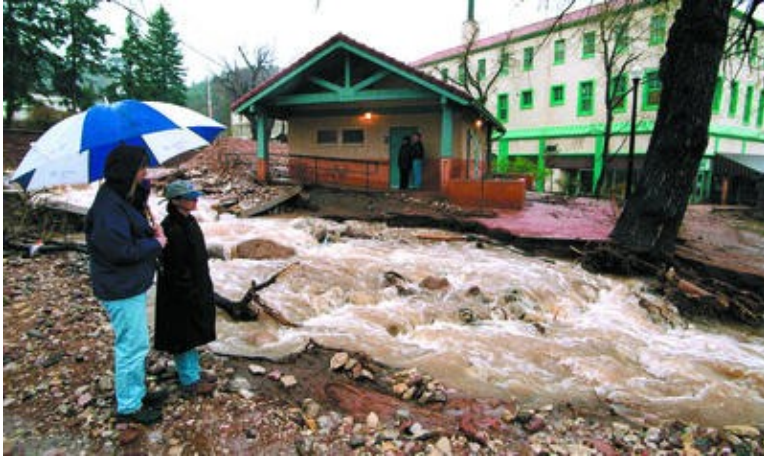
Attachment 2f - 1999

Mary McNamara, of Colorado Springs, and Suzanne Green, of Manitou Springs, watch the floodwaters flow through Soda Springs Park and into Fountain Creek, Saturday May 1, 1999 in Colorado Springs, Colo., near the historic and troubled Manitou Spa building. In Larimer County, some 60 people were evacuated from a flooded trailer park, and around Colorado Springs, homes were evacuated and two towns declared local disasters. (AP Photo/The Gazette, Bob Jackson)

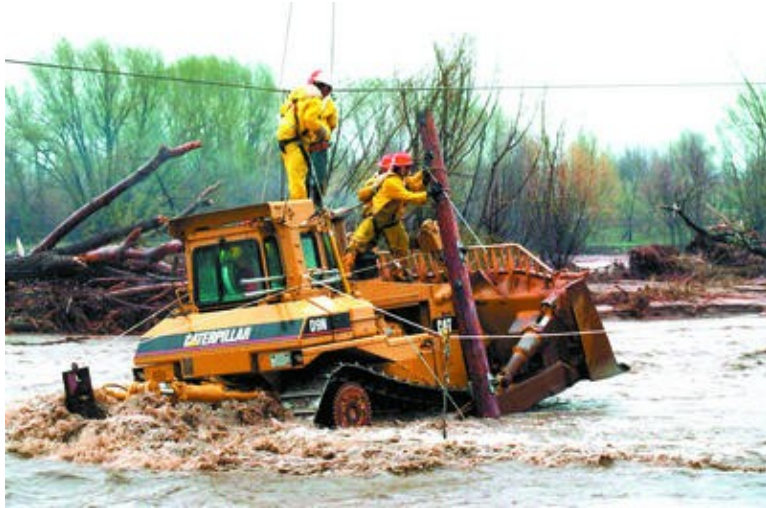
Attachment 2g - 1999

Utilities workers from Colorado Springs and Fountain, Colo. work on damaged power lines near Fountain on Saturday May 1, 1999. The lines were damaged Friday by debris washing down Fountain Creek causing a major power outage. (AP Photo/The Gazette, Jay Janner)

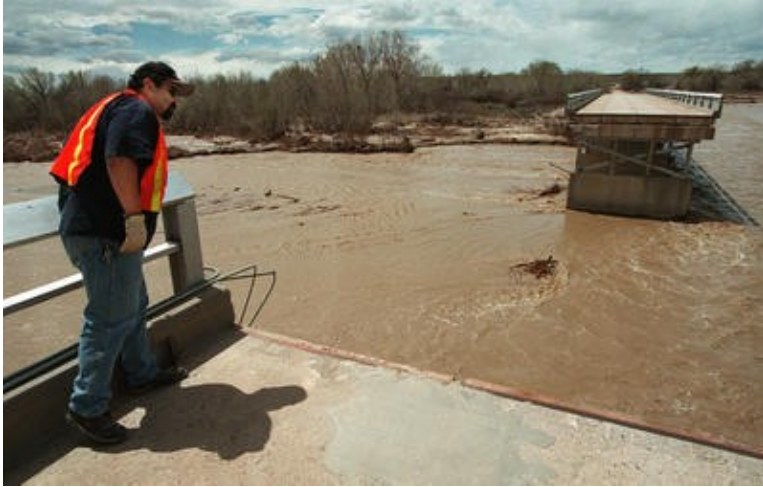
Attachment 2h - 1999

Don Maldonado, a worker with the Pueblo County Department of Public Works, surveys the damage done to the Pinon bridge which crosses the Fountain River near Pueblo, Colo., Monday May 3, 1999. A section of the bridge was washed away during Friday's storm which turned the usually tame Fountain into a raging torrent. (AP Photo)(The Pueblo Chieftain, Bryan Kelsen)

May 17, 1995 and June 1997 — Large rainstorms cause heavy channel erosion on Fountain Creek, including washing out Pinon Road and areas around Pinon Bridge and (1997) causing one pier to settle by 9 inches. Pueblo County public works officials propose study of possible construction of dam on creek.

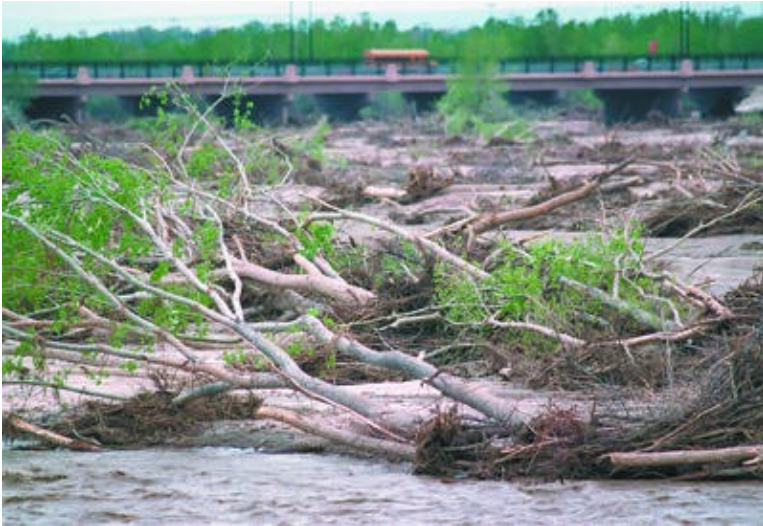
Attachment 2i - 1999

Hundreds of trees fill the Fountain River riverbed just north of the Highway 47 bridge Monday. The trees are part of the debris left when the waters of the flooding river receded. Chieftain Photo by Bryan Kelsen

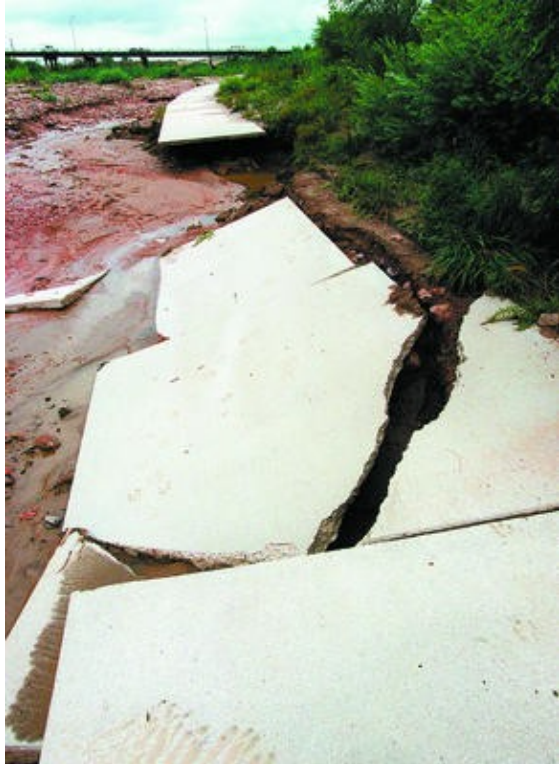
Attachment 2j - 1999

Recent rains that have caused flooding along Fountain Creek have also caused extensive damage to the river trail south of the east fourth Street bridge — photo by Chris McLean 8-2-99

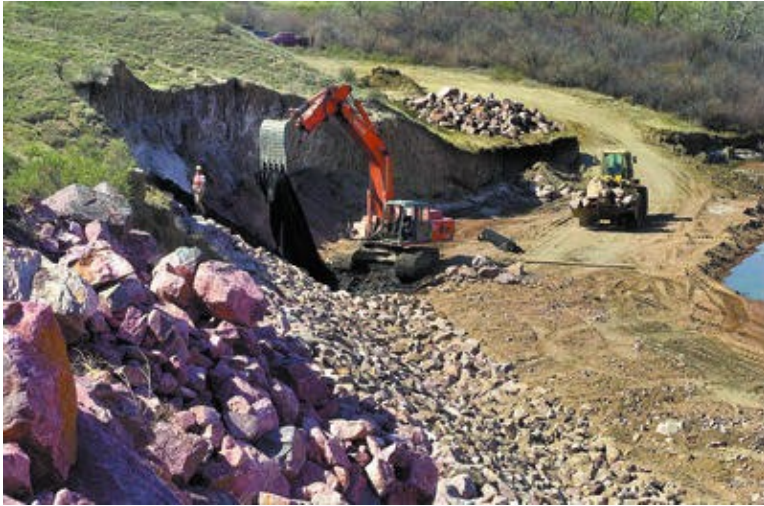
Attachment 2k - 2001

The Union Pacific Railroad is shoring up the cliff adjacent to their railroad tracks along the Fountain River just north of Pueblo near the Eden exit of Interstate 25. During the 1999 flood, the river cut a new channel that eroded the cliff and brought it closer to the tracks that run alongside to the left. They are installing mesh fabric to secure large rocks and riprap along about a 1-mile stretch. The work began last week and should continue for about 6 weeks—photo by chris mclean 4-26-01

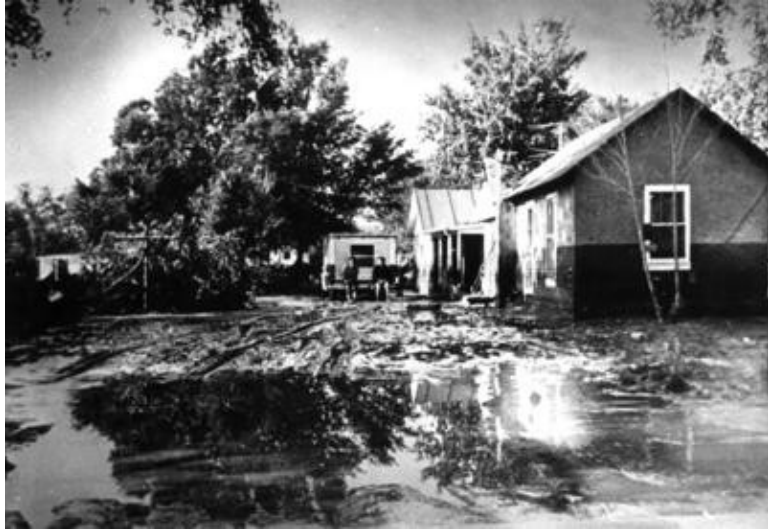
Attachment 21 - 1965

floodwaters inundate an east side home during the 1965 flood in pueblo -- chieftain file photo

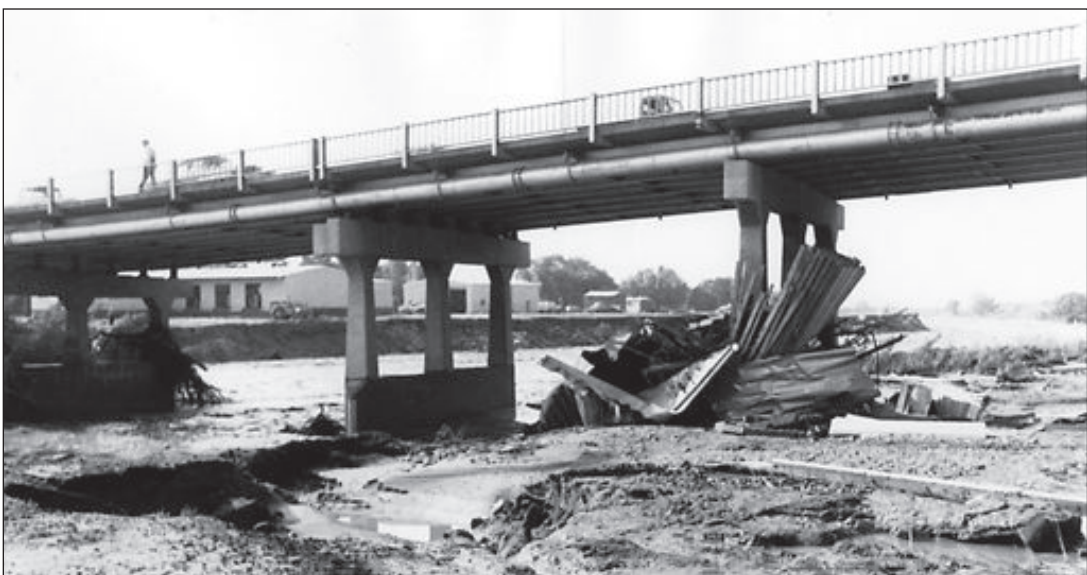
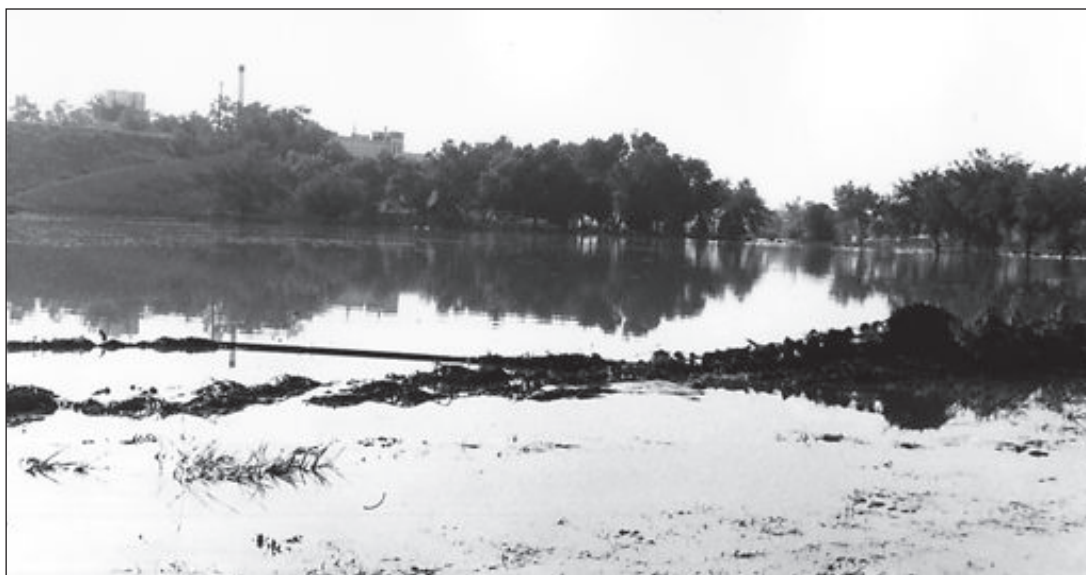
Debris from a building (left photo) that washed up against the Eighth Street bridge was left behind when floodwaters receded in 1965. Lower Fountain Creek (right photo) briefly turned into a lake below the old Walter's Brewery during the flood of 1965.

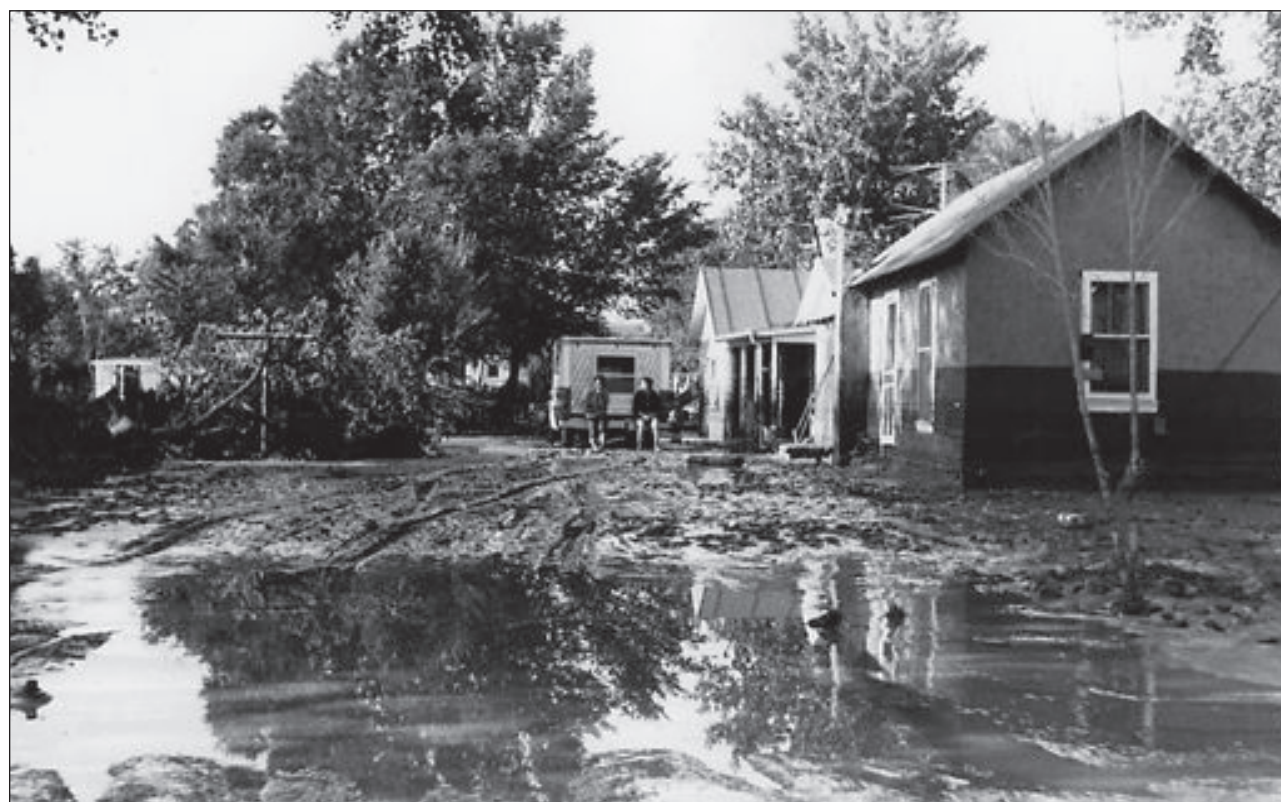
East Side residents survey a muddy yard while cleaning up after the 1965 flood on Fountain Creek. The dark area on the walls of the house shows the high-water mark from flooding.

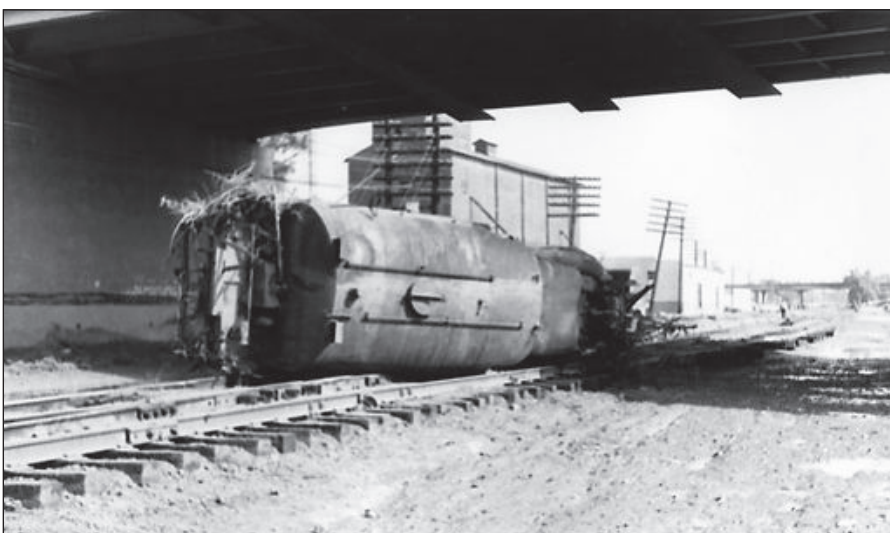
A railroad tanker rests on its side after floodwaters receded from the June 17, 1965, flood on Fountain Creek.

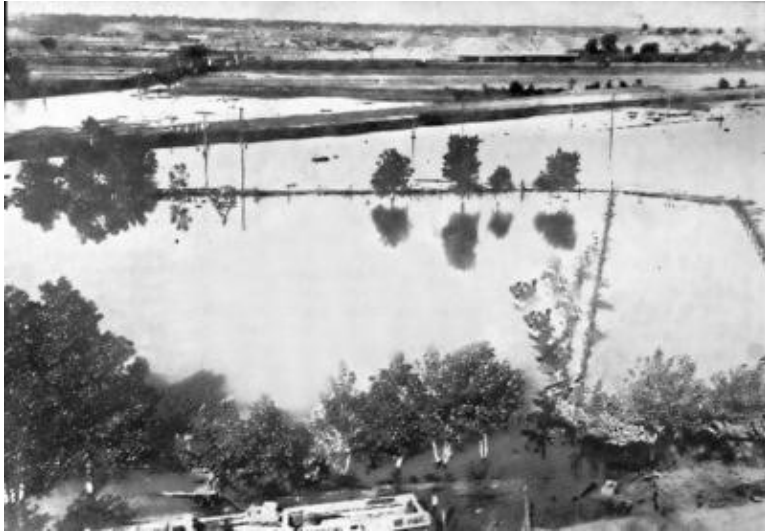
Attachment 2n - 1935

photo shows the ackup water close to the Walter's Brewing Company—from page 7 of June 1, 1935 Pueblo Chieftain

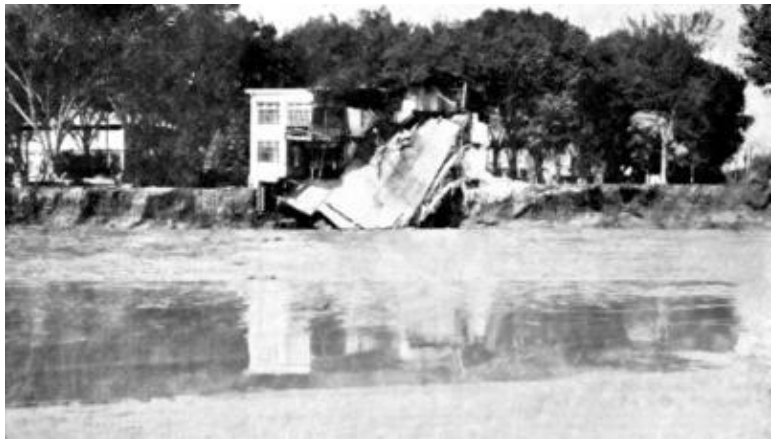
Attachment 2r - 1935

photo shows the men's dormitory at state hospital annex tumbling into the swollen river

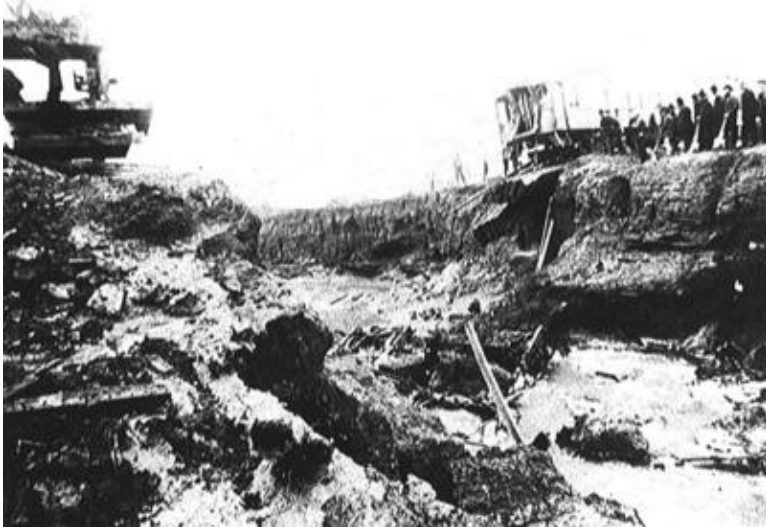
Attachment 2s - 1904

1904 Aug. 7--a flash flood north of pueblo washed a train from the tracks, killing 89 passengers file photo
