Project Effectiveness Study February 16, 2024

Tori Mack, PE Water Resources Engineer

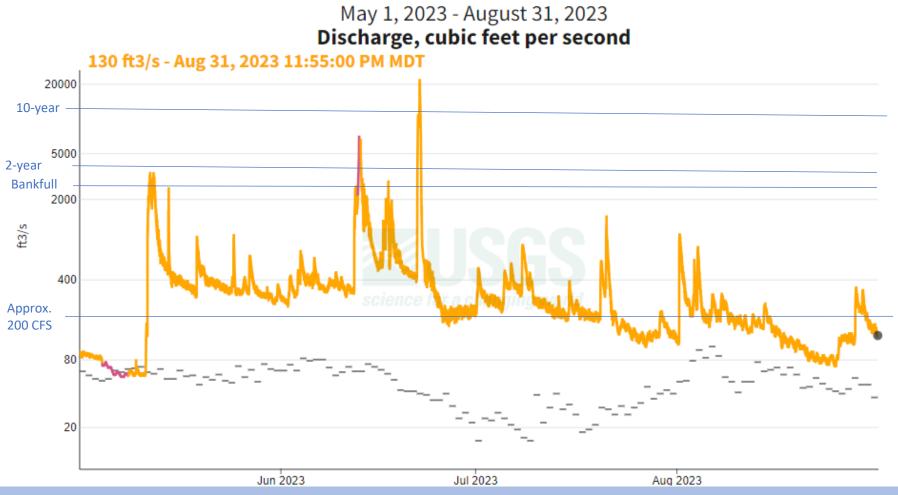
Fountain Creek at Pueblo, Co. - 07106500

Hydrology at Highway 47

Recurrence Interval	Mean Annual Flow	Bankfull Flow	2-Year	5-Year	10-Year	June 16, 2015 Event	50-Year	100-Year	500-Year
Discharge (ft ³ /s)	158	2,990	4,600	9,500	14,400	18,500	30,200	39,600	70,000

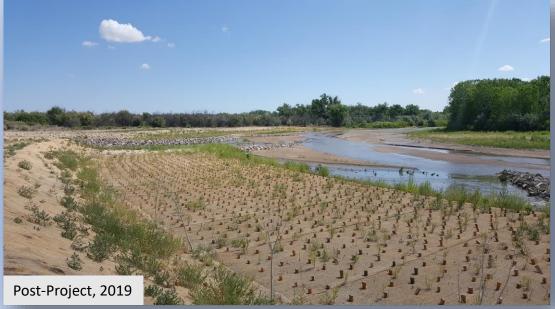
Bank PC003, Looking Upstream

- Stable site
- Dense riparian vegetation
- Multi-threaded channel
- Sediment

Bank	Pre-Project (tons/year)	Post-Project (tons/year)
PC003	13,653	Negligible

Project Site	Recommendation
Masciantonio Trust Bank and Young Hollow	Weed control for minimum of two years with focus on salt cedar and Russian olive.
Overton Road Bank Restoration	Monitoring of post-flood conditions in 2024. Weed control for minimum of two years with focus on salt cedar.
Pinon Bridge	Monitoring of post-flood conditions in 2024. Vegetation monitoring and weed control for minimum of two years.
Barr Farm, Phase 2	Monitoring of bend migration in 2024 and annually. Vegetation monitoring and weed control for minimum of two years.
Barr Farm, Phase 1	Monitoring of toe wood bend and confined area in 2024. Vegetation monitoring and weed control for minimum of two years.
Highway 47 Bank Restoration	Additional action recommended. In discussion. Vegetation monitoring and weed control for minimum of two years. Interseeding areas with low native cover.
13 th Street Channel Restoration	Additional action recommended. In discussion. Vegetation monitoring and weed control for minimum of two years. Interseeding areas with low native cover.

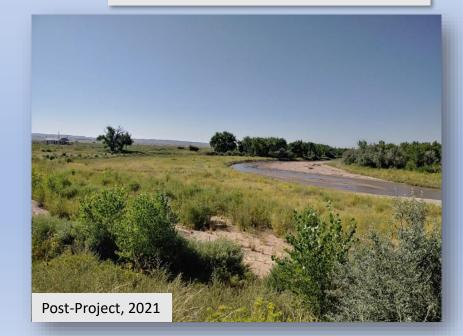
Bank PC070, Looking Downstream

- Findings
 - Excessive sediment deposition
 - Potential flanking of the bend protection
- Sediment major bank

Bank	Pre-Project (tons/year)	Post-Project (tons/year)
PC070	16,225	Negligible

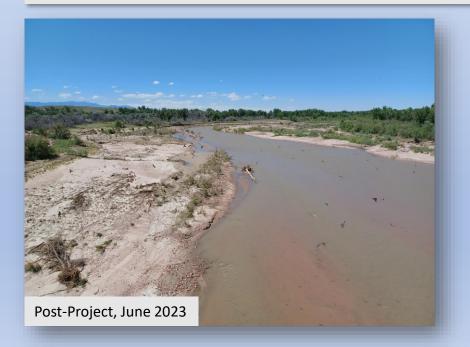
Pinon Project, Looking Upstream from the Bridge

- Flanking on downstream end of bend protection
- Other components intact
- Sediment major bank

Post-Project (tons/year)
PC017	9,242	Negligible

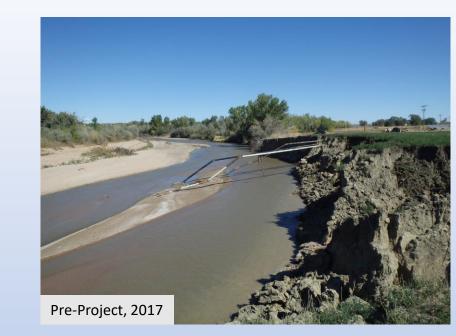
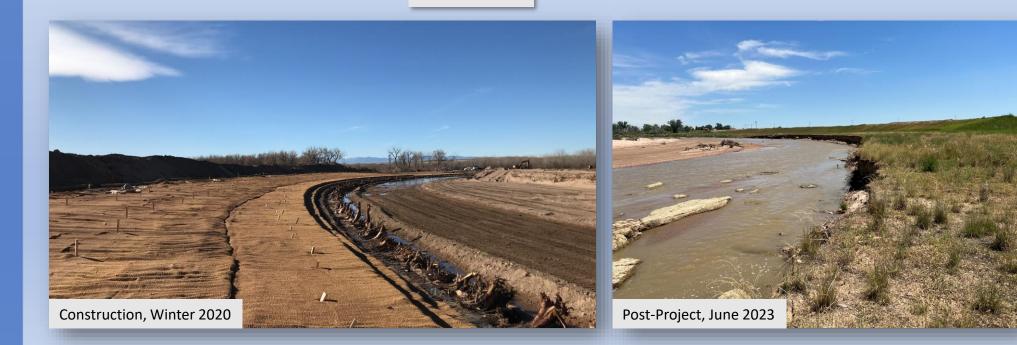
Bank PC079

- Undermining of toe wood bank protection.
- Sediment
 - Rate = 0.19 tons/yr/ft
 - Post-Project total = 1,371 tons/year

Bank ID	Pre-Project (tons/year)
PC021	2,525
PC078	27,284
PC079	19,758
PC080	5,156
Total	54,732

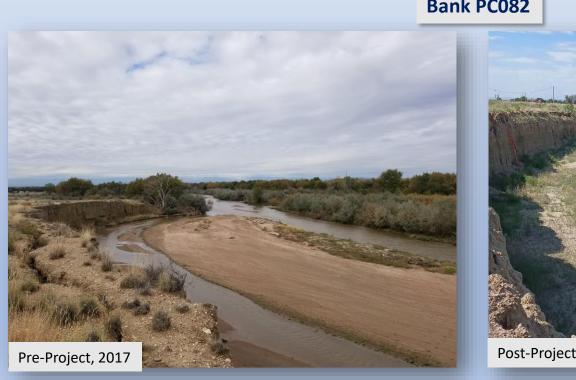
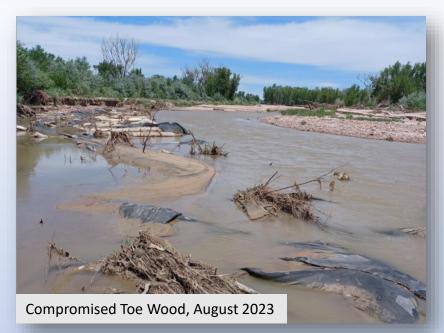
Bank PC082

- Findings
 - Undermining of toe wood bank protection.
 - Some riprap flanking on downstream side and aggradation in the point bars.
- Sediment
 - Rate = 0.06 tons/yr/ft
 - Post-Project total = 312 tons/year

Bank ID	Estimated Erosion Rate (tons/year)
PC022	1,199
PC081	28,427
PC082	25,189
Totals	54,814

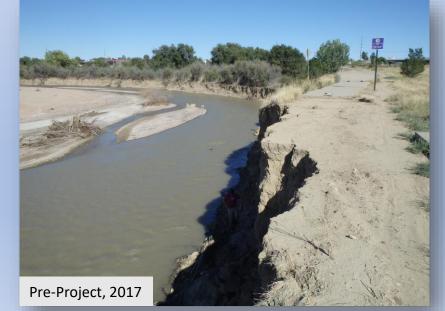
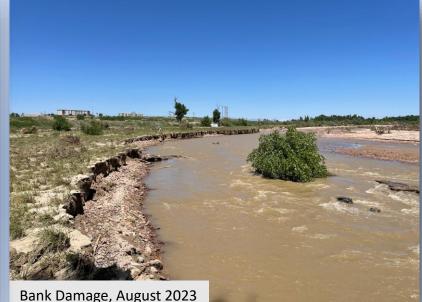
- Project Objectives
 - Protection of the Highway 47 Bridge
- Findings
 - Significant site damage
- Sediment
 - Post-Project Contribution = 4,442 tons/year

Estimated Erosion Rate
Bank ID	(tons/year)
PC044	6,422
PC045	2,686
PC046	4,149
PC106	7,633
PC107	742
PC108	5,582
PC109	3,255
Totals	30,468

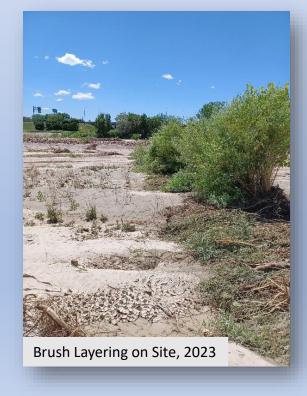
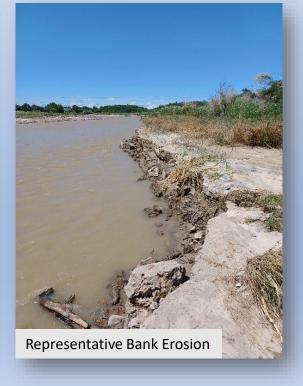
- Project Objectives
 - Reduce sediment contributions to site.
 - Protection of levee and railroad.
 - Findings

Ongoing migration of thalweg

- Sediment
 - Rate = 0.19 tons/yr/ft
 - Post-Project total = 532 tons/year
