Project Effectiveness Evaluation

Summary of Findings

February 1, 2024

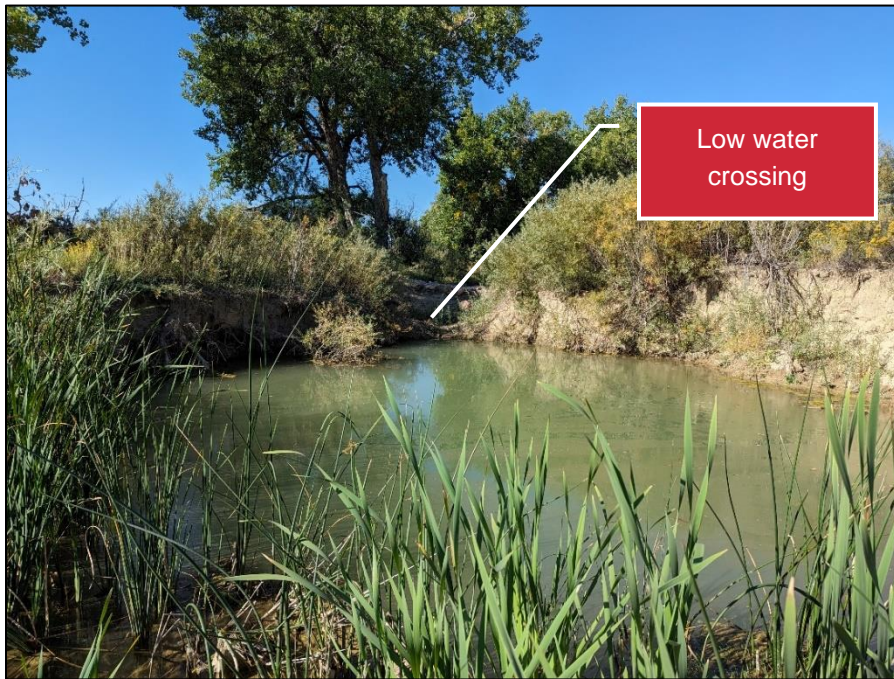
A large pool has is located downstream of the crossing, which was formed prior to crossing improvements. Site observations suggest that riprap held the elevation of the road crossing, but the crossing appears to have functioned as a drop structure, causing excessive downstream forces; this scour pool is shown in Figure 8. Steep banks are present at the pool, but, as the drainage transitions back into Fountain Creek, vegetation has been established, increasing the stability of the confluence area (Figure 9).

Figure 8. Young Hollow looking upstream at scour pool.

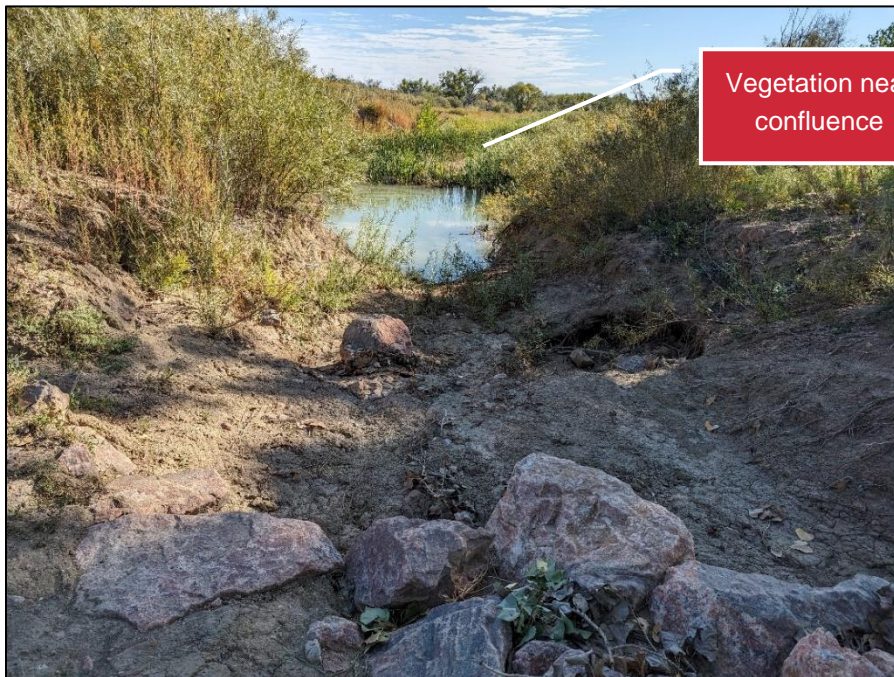
Figure 9. Low water crossing, looking downstream.

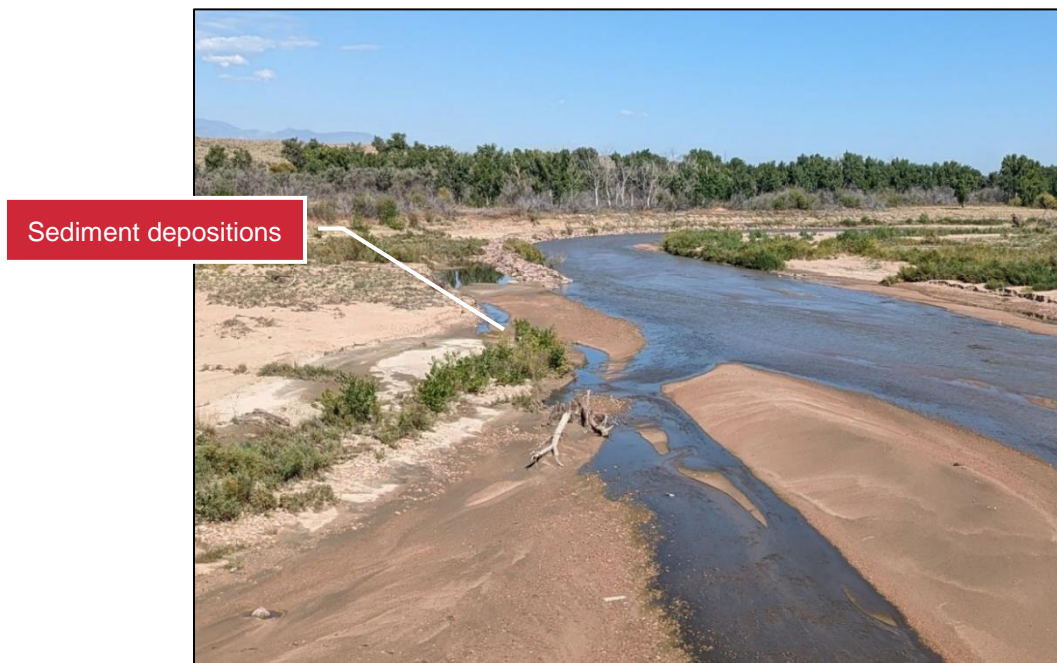
A follow-up photo of the bank protection was taken in September 2023, showing sediment deposition between the end of the bank protection and the downstream point bar, shown in Figure 16. It appears that sediment is backfilling the area behind and downstream of the point bar, reestablishing the design pattern.

Figure 16. Riprap bank protection upstream of the Pinon Rd bridge, September 2023.

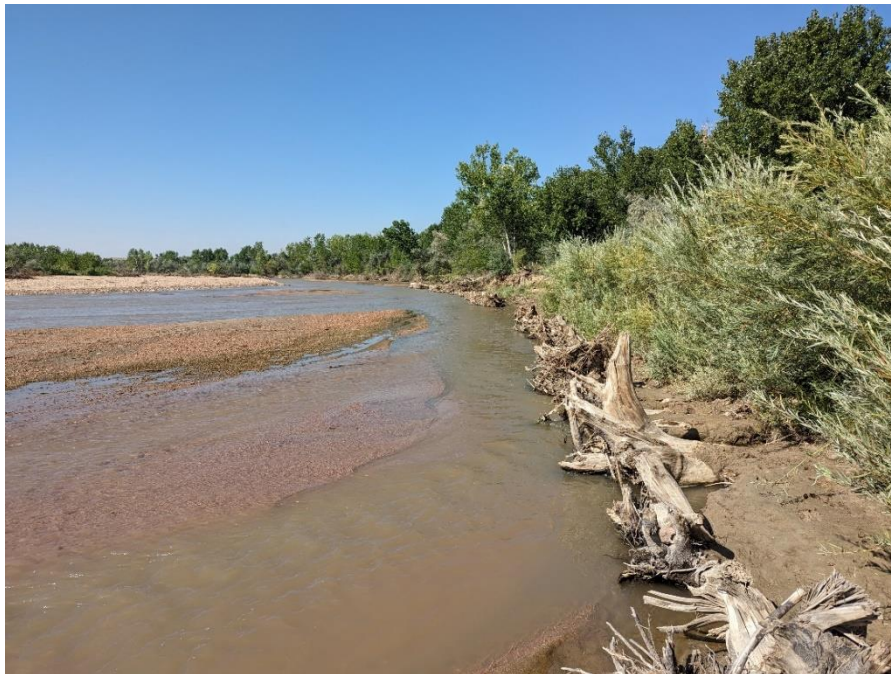
Not all areas of toe wood are at risk. Sections of the bank protection remain, as shown in Figure 25. These areas are typically along the upstream end of bends where the hydraulic forces were lowest.

Figure 25. Intact toe wood sections.

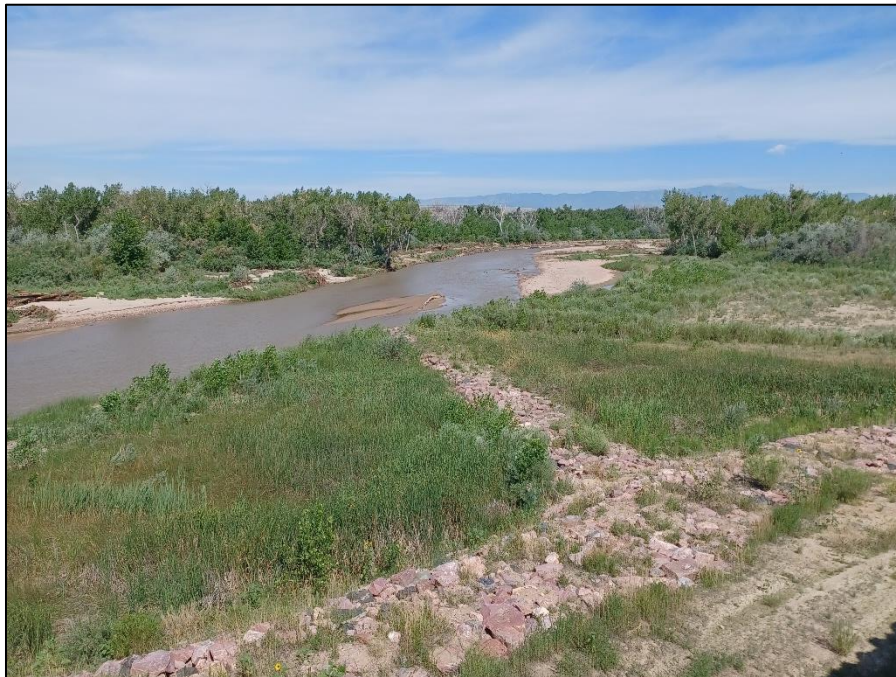
The site was assessed downstream to upstream. The downstream tie-in of the project site was well established in the design pattern and a stable bar on the inside of the bend has been established. This area is shown in Figure 26. The top of the historic cut bank is still visible at the downstream tie in. Heavy wetland vegetation was found in this area due to good groundwater connection in the area, shown in Figure 27. At the upstream tie in of this bank protection, the soil lifts installed above the riprap are still intact with some loose fabric visible in Figure 28.

Figure 27. Heavy vegetation establishment on floodplain.

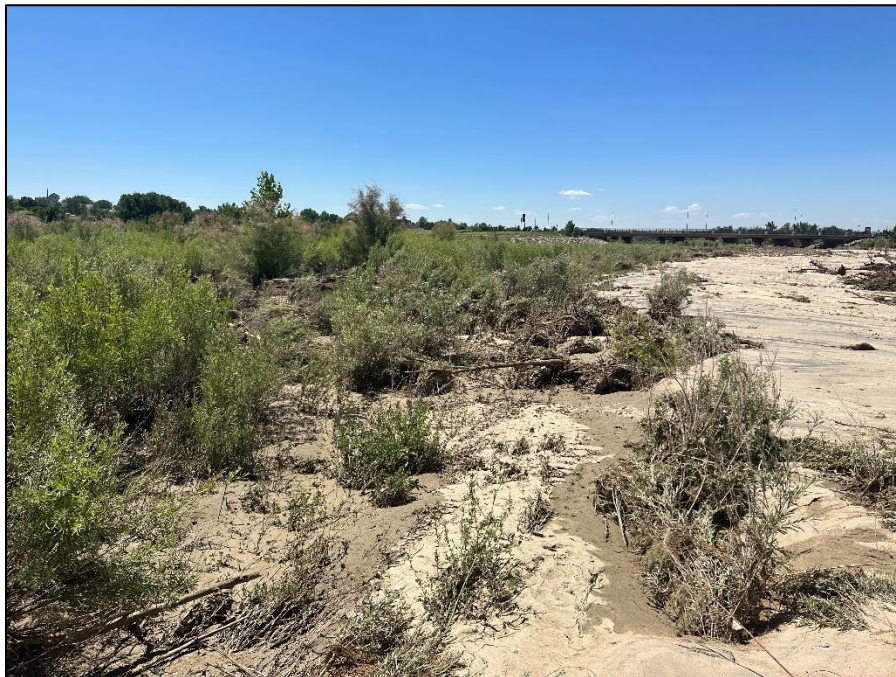
During the site assessment, it was noted that much of the previously established vegetation was buried by the fine sediment deposited throughout the floodplain. Despite this, willows bent over by the flooding but unburied appeared to be alive and will likely survive. Cottonwood poles planted as part of the revegetation effort remain within the floodplain and are largely unaffected by the flooding. An example of the vegetation remaining on the floodplain and sediment deposition closer to the creek is shown in Figure 34.

Figure 34. Vegetation in the floodplain.

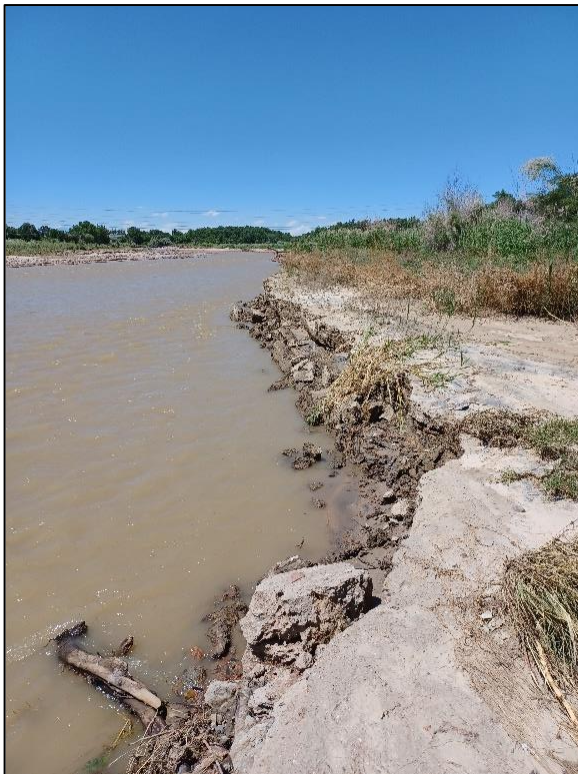
Over time, the thalweg of Fountain Creek within this project area has followed a straighter alignment than is expected on Fountain Creek and not consistent with the project design. Due to this, there has been sediment deposition within the boundaries of the bankfull channel. Erosion on the project site was noted to be exclusively on these sediment deposition areas as is shown in Figure 35. Flood flows appear to have been mostly contained within the bankfull corridor.

Figure 35. Bank erosion, typical to the site.

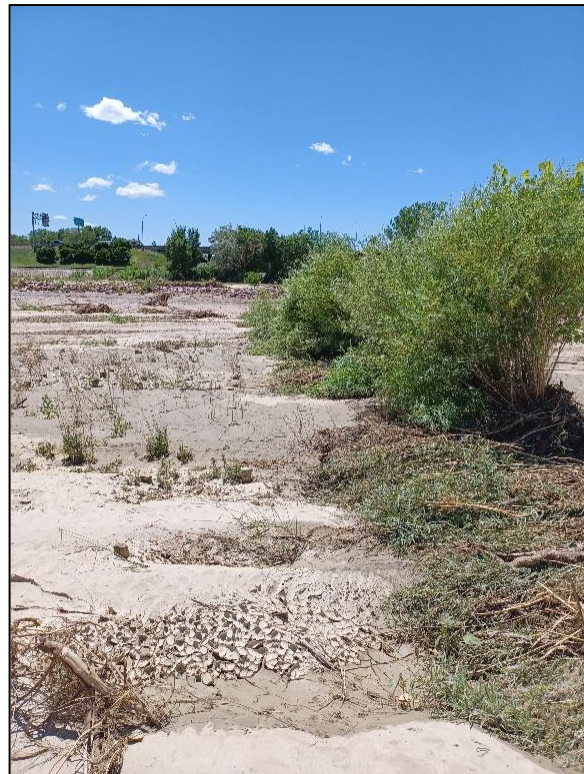
On site vegetation has been largely buried by fine sediment within the flooding extents. Shown in Figure 36, brush layering on site has successfully established.

Figure 36. On-site brush layering.
